BR Brick Bracket Testing

**NTA 15-03,
LEDGER-TO-RIM BOARD BRACKET TEST:
ASSEMBLIES CONSTRUCTED WITH BRICK BRACKETS AND
(4) COMBINATIONS OF RIM AND LEDGER BOARDS**

Test Report: BRBB111815-38
Issued: January 8, 2016

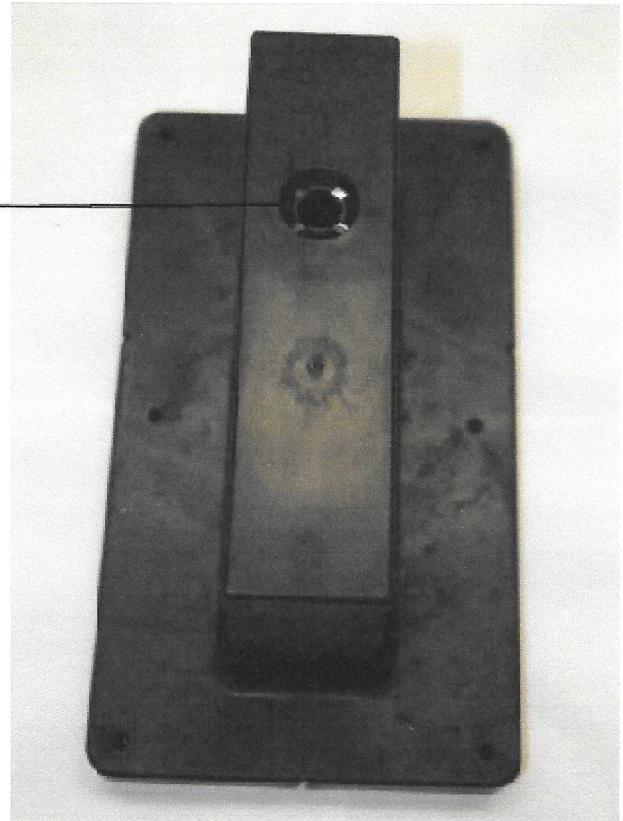
Fig.1

Off-center 9/16" bolt hole allows for staggered bolt pattern per IRC

The bracket was designed to be installed with the bolt either toward the top or the bottom of the bracket. The off-center bolt hole location allows for a staggered bolt pattern, per IRC requirements. To establish worst-case loading condition, all tests were performed with the bolt in the lower (down) position. This orientation was considered to be the most conservative installation technique.

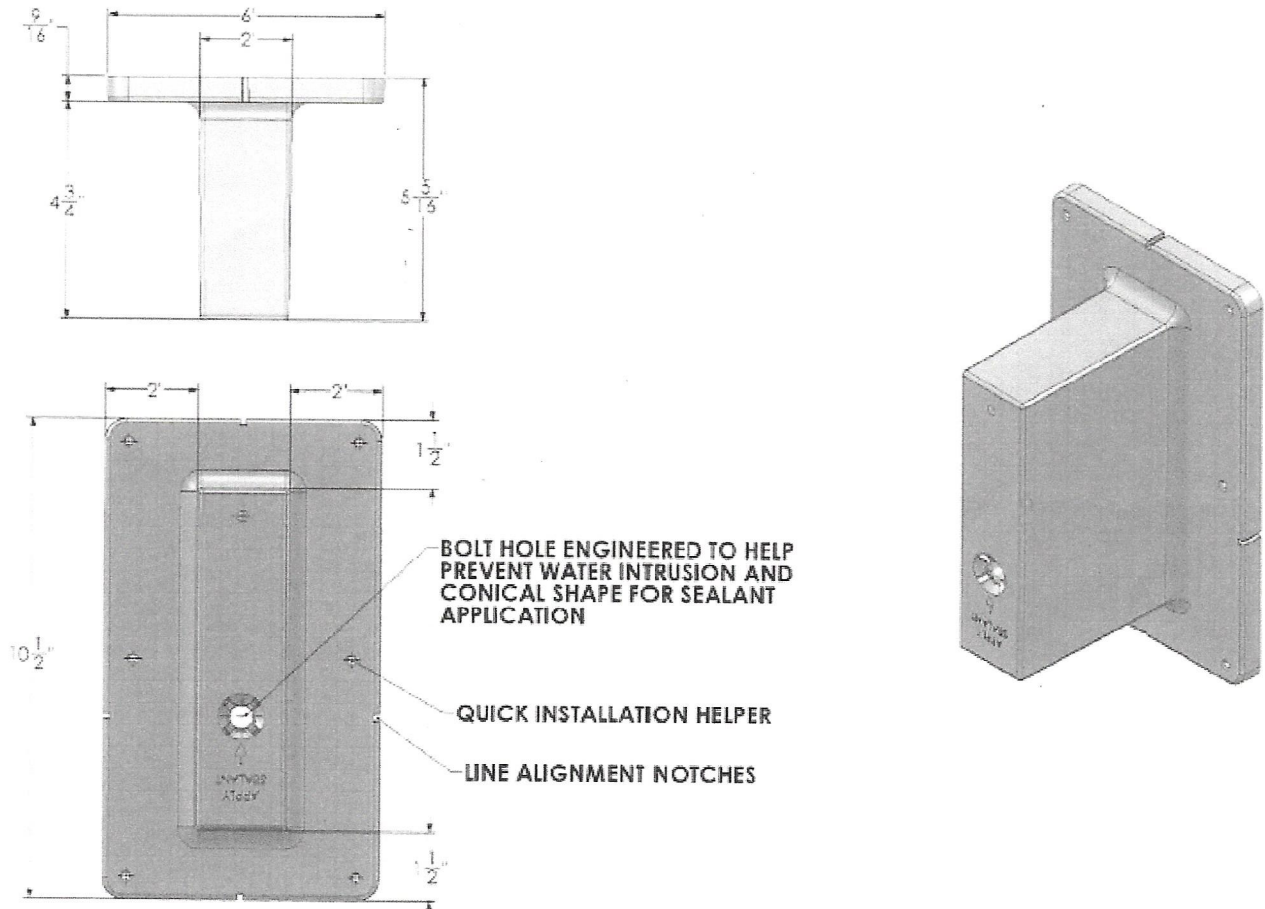
Figure 1: Brick Bracket Dimensions, Drawing Supplied by Client
Note: NTA did NOT evaluate the Bolt Hole for Water Intrusion or Sealability

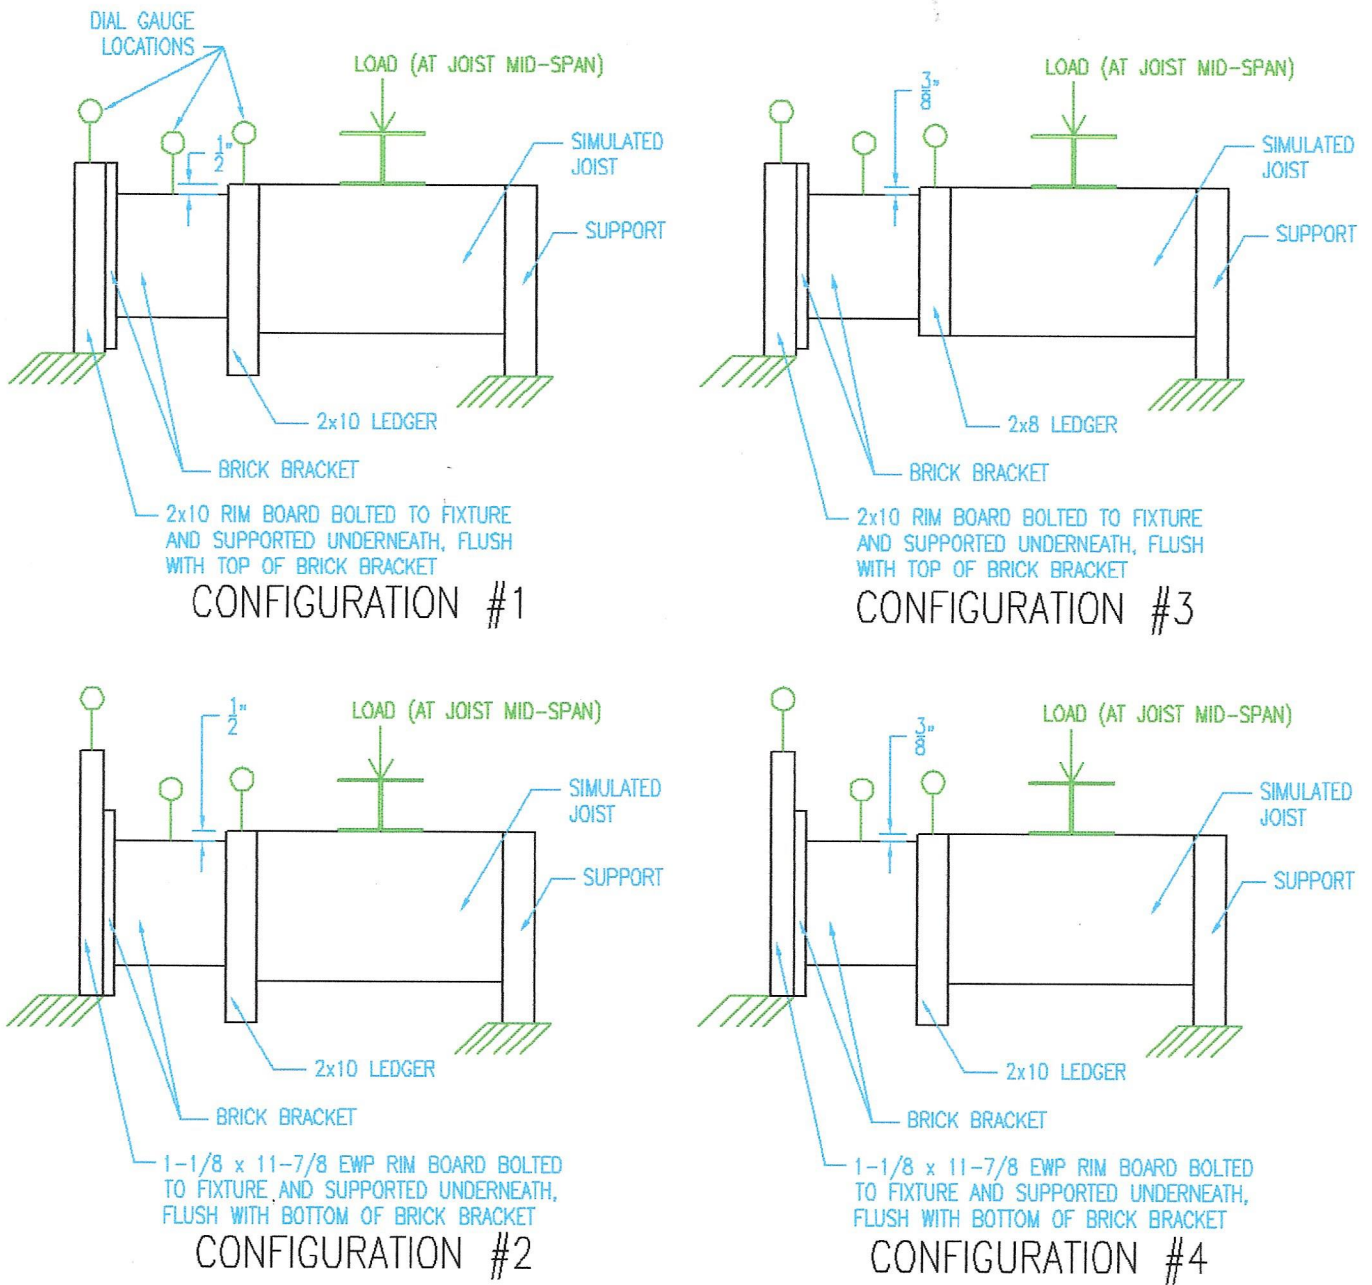
Figure 2: Test Construction / Setup Schematics for Each Configuration

Configuration	Rim Board	Ledger	Simulated Joist	Joist Hanger
1	Un-Treated 2x10 #2 SYP	PPT 2x10 #2 SYP	2x8 #1 Non-Treated SYP	Simpson Strong-Tie HUS 28
2	1-1/8 in. x 11-7/8 in. Engineered Wood OSB, Exposure 1, PRR-410	PPT 2x10 #2 SYP		
3	Un-Treated 2x10 #2 SYP	PPT 2x8 #2 SYP		
4	1-1/8 in. x 11-7/8 in. Engineered Wood OSB, Exposure 1, PRR-410	PPT 2x8 #2 SYP		
Notes: Not every piece of lumber received from the client contained a grade stamp. See Figure 2 for test setup and construction schematics for the tested configurations.

Five specimens were assembled for testing per the construction details herein. Each assembly was individually placed into the test machine and dial gauges were placed as shown in the photographs in Figures 14 and 16 and the schematic in Figure 2. For this testing dial gauges were located at the following places: mid-span and mid-width of the top face of the Brick Bracket, mid-span and mid-width of the ledger board, and at mid-width of the rim board near the support fixture. The rim board was bolted to a support fixture and supported under its bottom surface, while the support board at the opposite end of the joists was under its bottom surface. Schematics of the test setups for each configuration are provided in Figure 2.

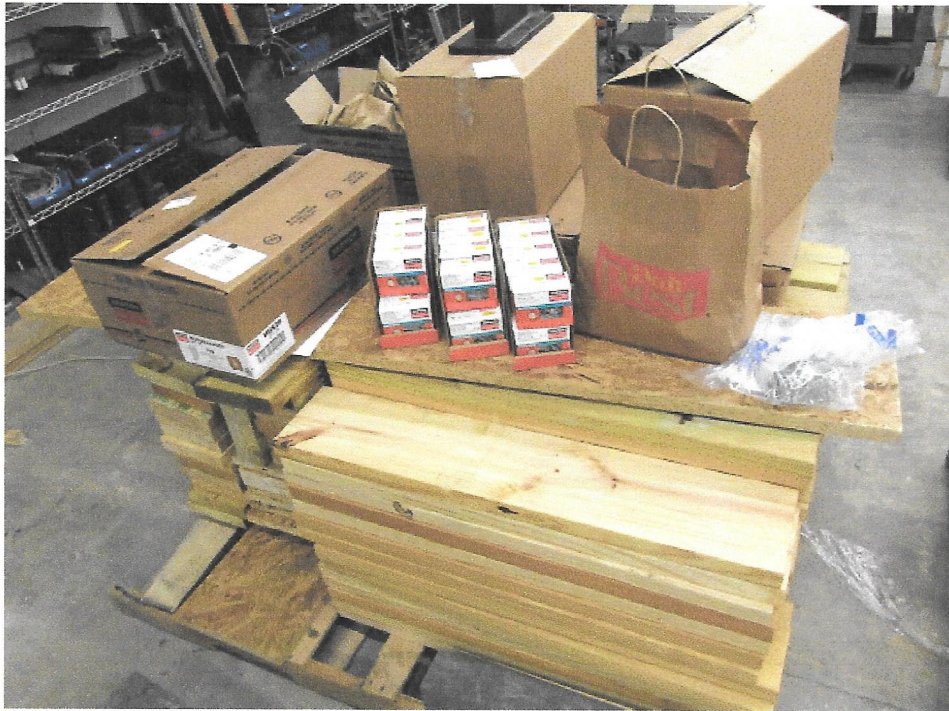
Figure 3: Materials Received from Client

The client provided Brick Brackets, bolts, washers, nails, joist hangers, screws, and lumber for construction of test assemblies. A summary of the materials and fastening is provided in Tables 2 and 3 and photographs of materials received are shown in Figures 3 through 9. Additionally, Figures 10 through 13 provide photographs of specimens during the construction process.

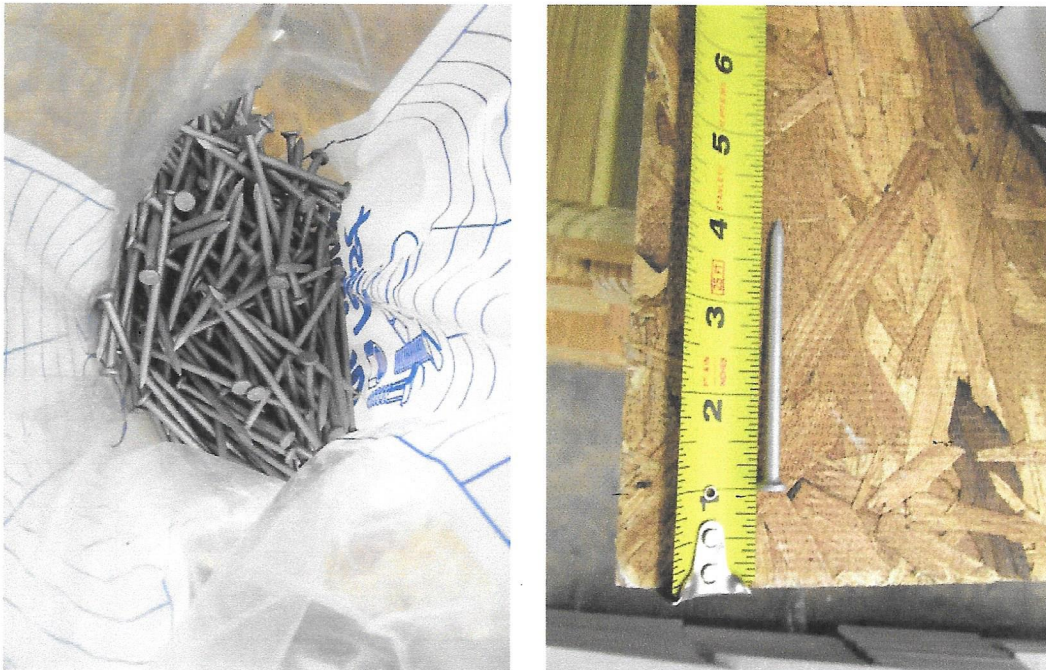
Figure 4: Nails Received from Client

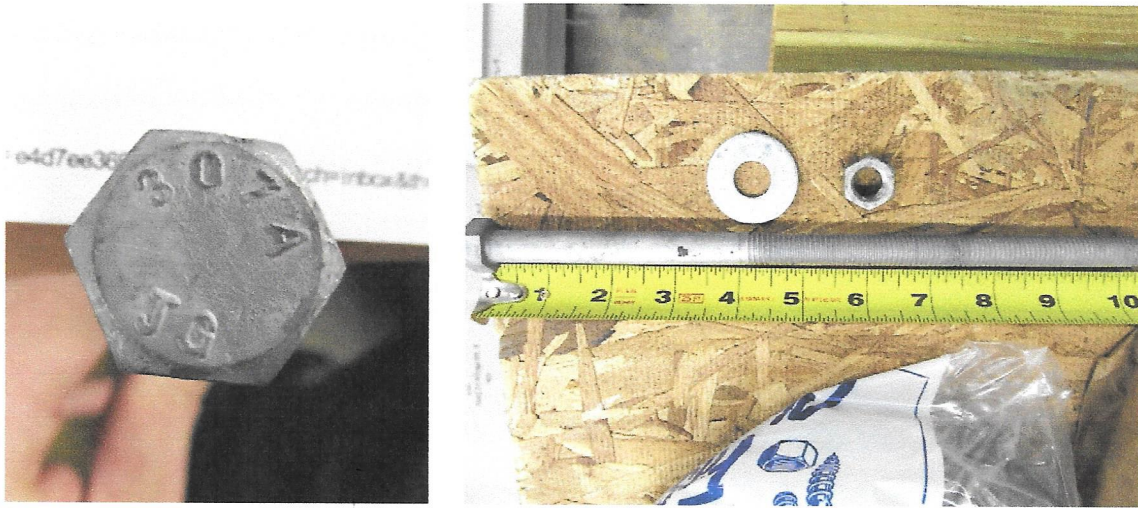
Figure 5: Example of a Bolt, Washer, and Nut Received from the Client

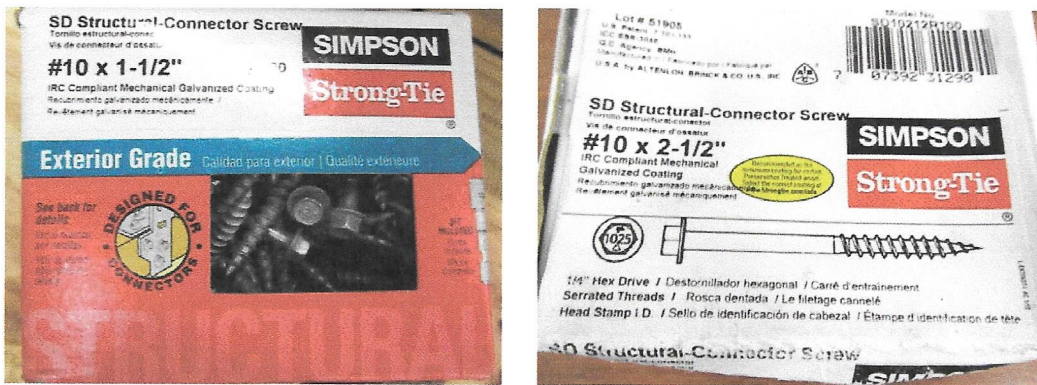
Figure 6: Simpson Joist Hanger Screws (1-1/2 in. Screws used into Ledger and 2-1/2 in. Screws used through Joists and into Ledger) Received from the Client

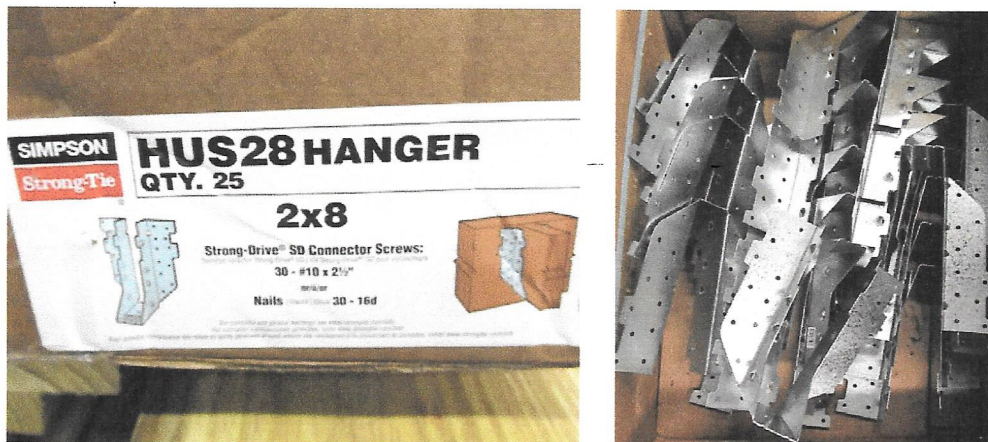
Figure 7: Joist Hangers Received from the Client

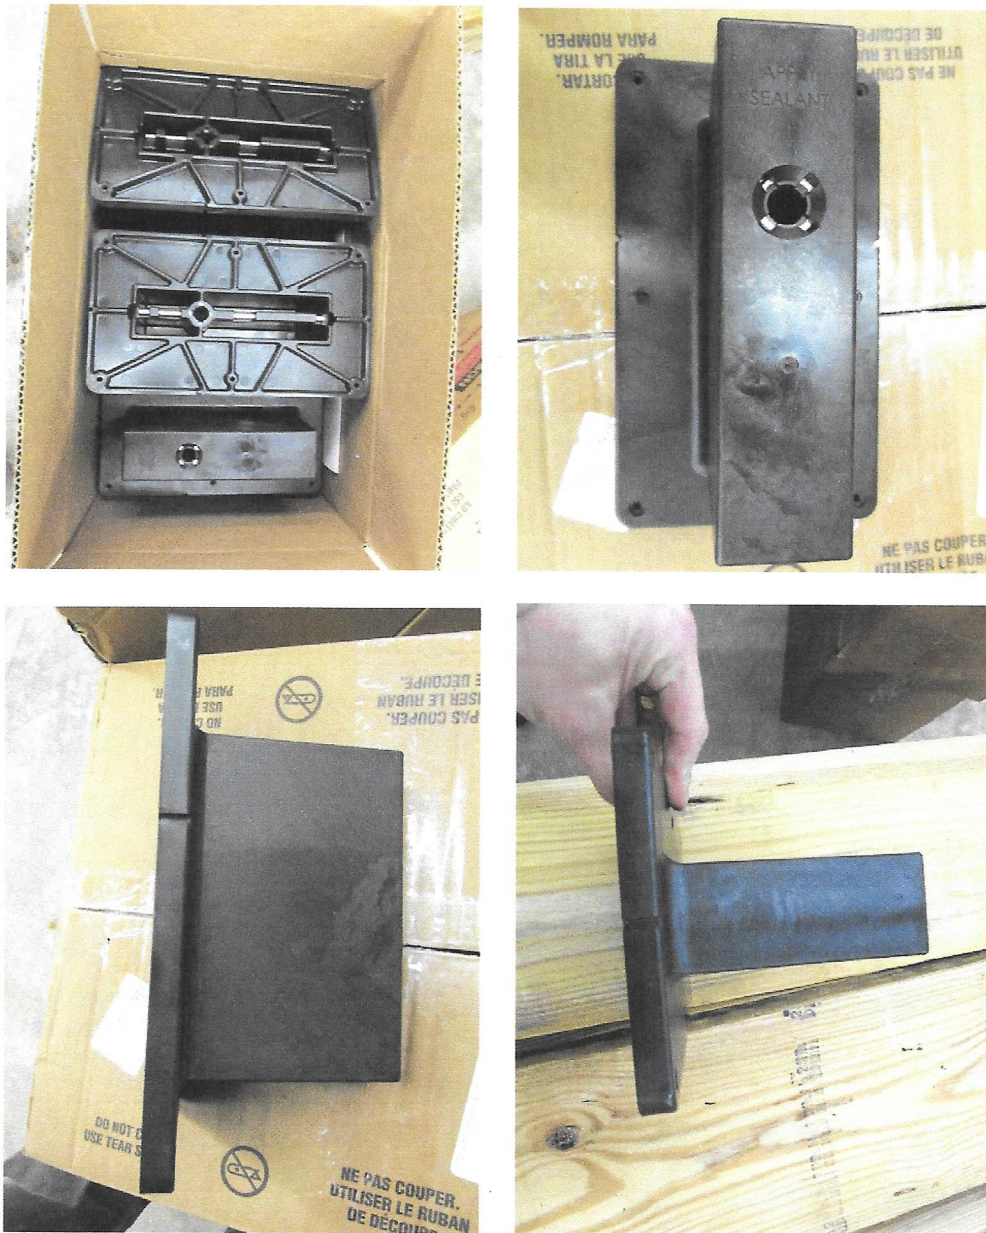
Figure 8: Brick Brackets Received from the Client

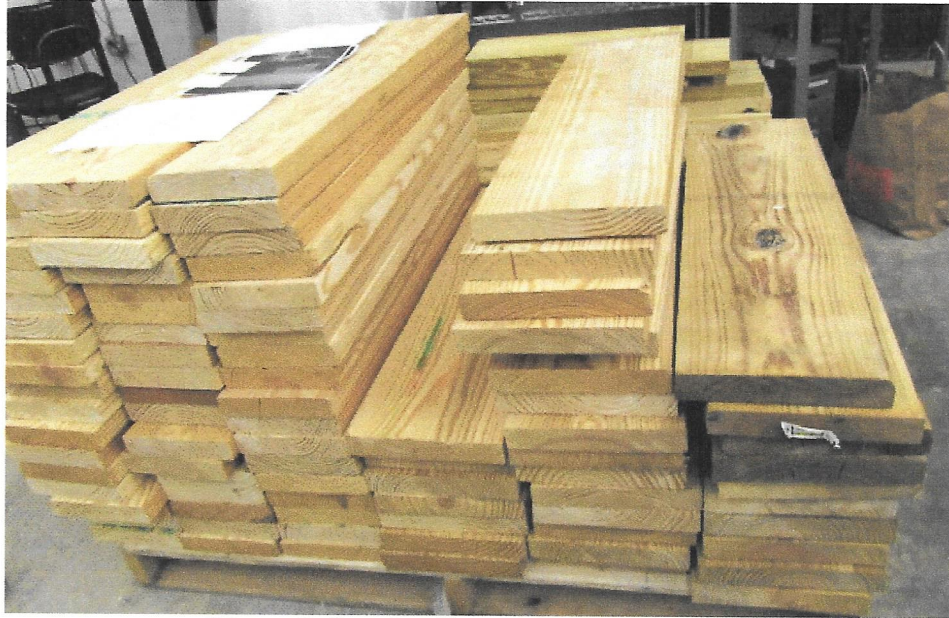
Figure 9: Lumber Received from the Client
Note: Not every piece contained a grade stamp.

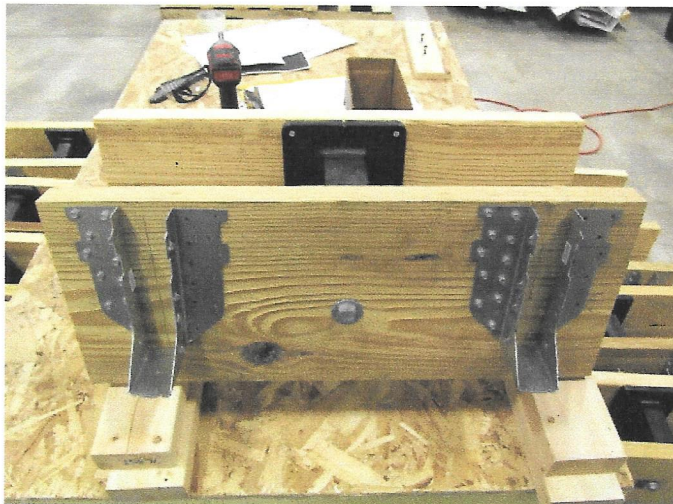
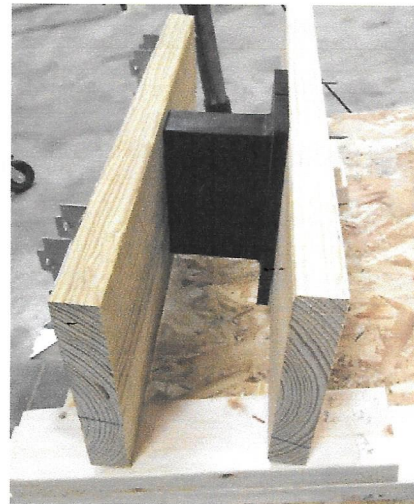
Figure 10: Constructing a Configuration 1 Specimen

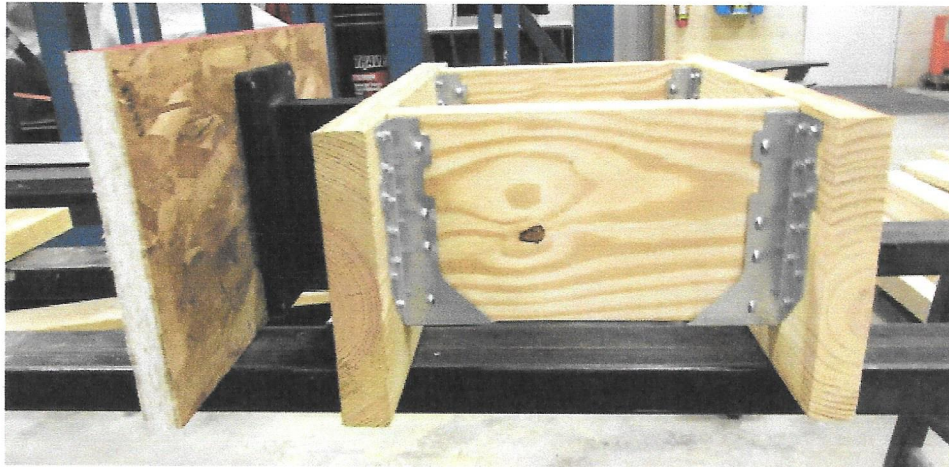
Figure 11: Constructing a Configuration 2 Specimen

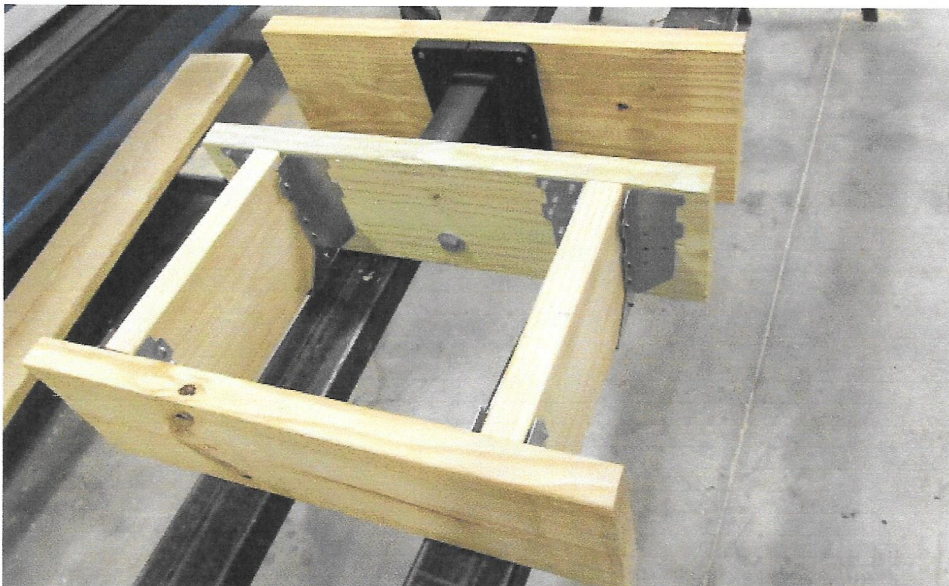
Figure 12: Constructing a Configuration 3 Specimen

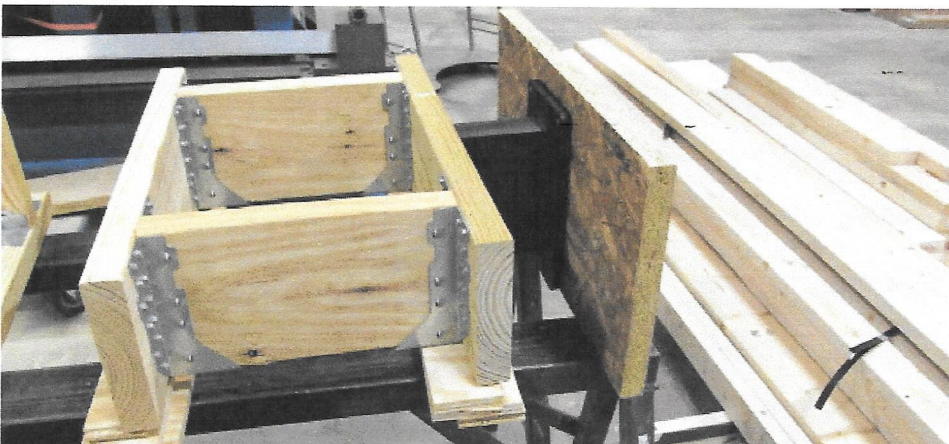
Figure 13: Constructing a Configuration 4 Specimen

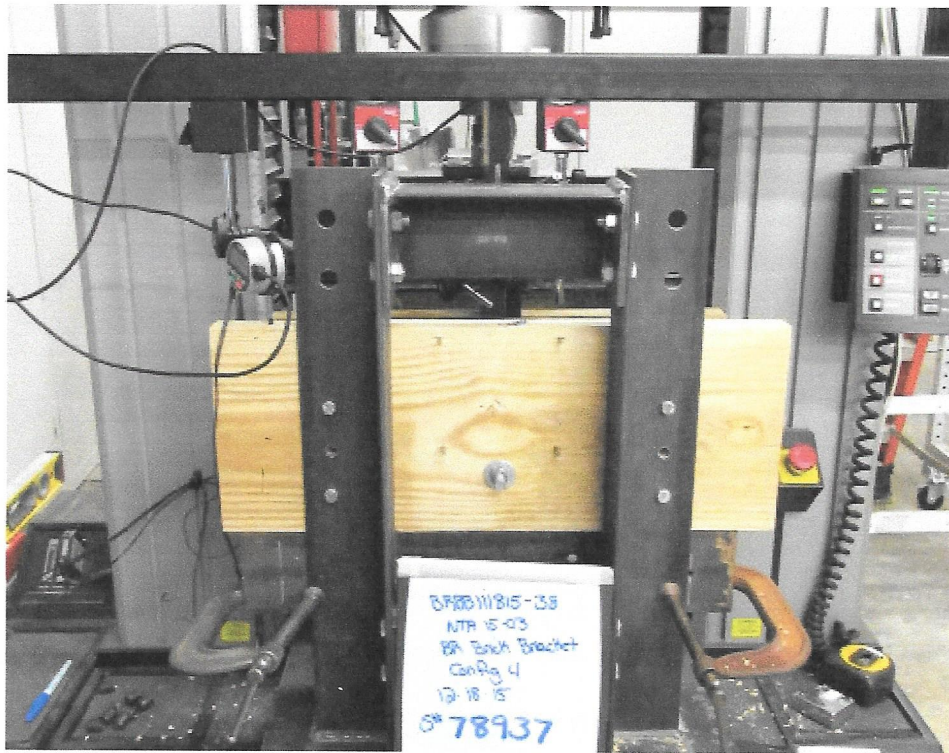
Figure 14: Test Setup Viewed from the Rim Board Side

Load was applied through a 4 in. wide steel I-beam at the mid-span of the two joists, as shown in Figures 14 through 16. Two pieces of polyethylene were placed between the I-beam and each joist to help reduce friction during the test. Load was applied at a rate of 0.50 inches per minute until ultimate load occurred. Throughout the test dial gauge readings were logged and deflection data was reported for loads specified by the client. At ultimate the failure mode was observed and recorded.

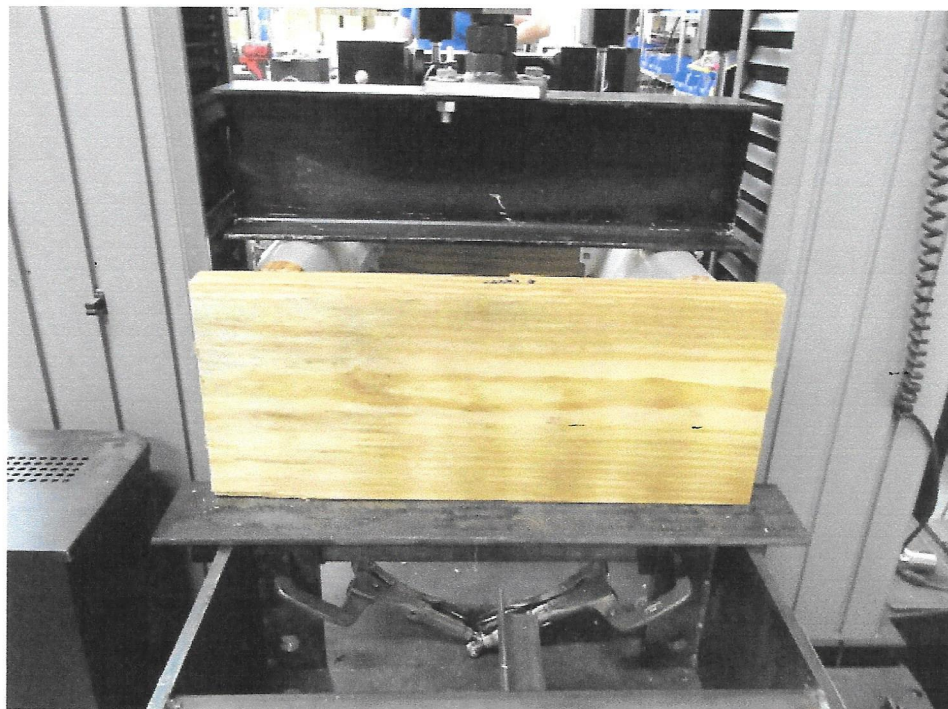
Figure 15: Test Setup Viewed from the Support Side and Showing the Load Application Beam

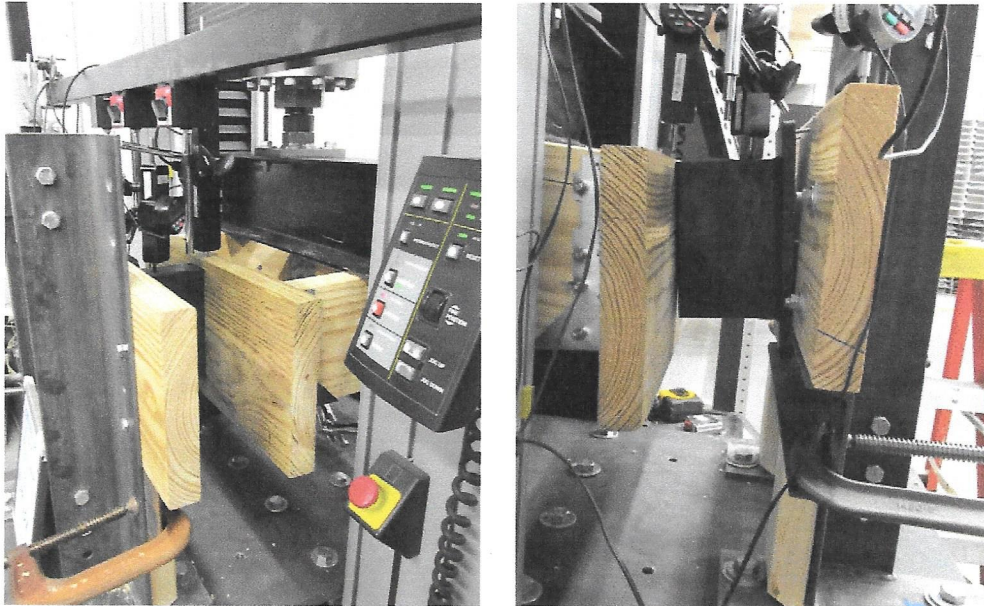
Figure 16: Additional Test Setup Views showing Dial Gauge Placements (Left and Right) and a Test In-Progress (Right)

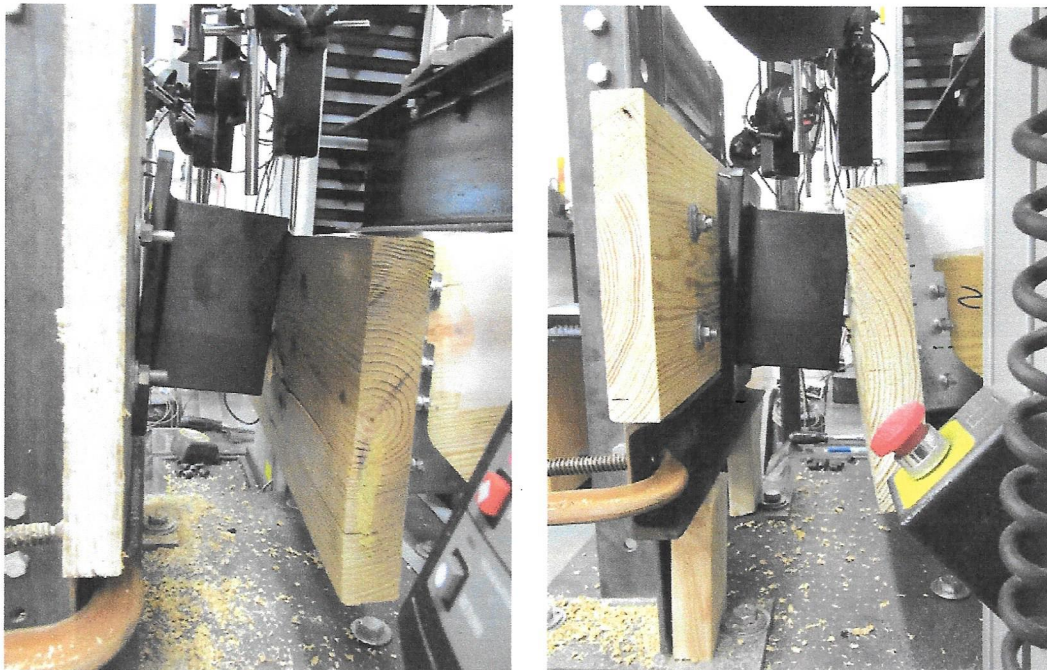
Figure 17: Test Specimens at Ultimate Load

Results for each test are summarized in Tables 4 through 6, below. The formula for the calculation of adjusted ultimate loads, as requested by the client, is given in Equation 1. Photographs of assemblies at ultimate load and of Brick Bracket and bolt components after testing are provided in Figures 17 through 19. Additional test data is provided in the Appendix.

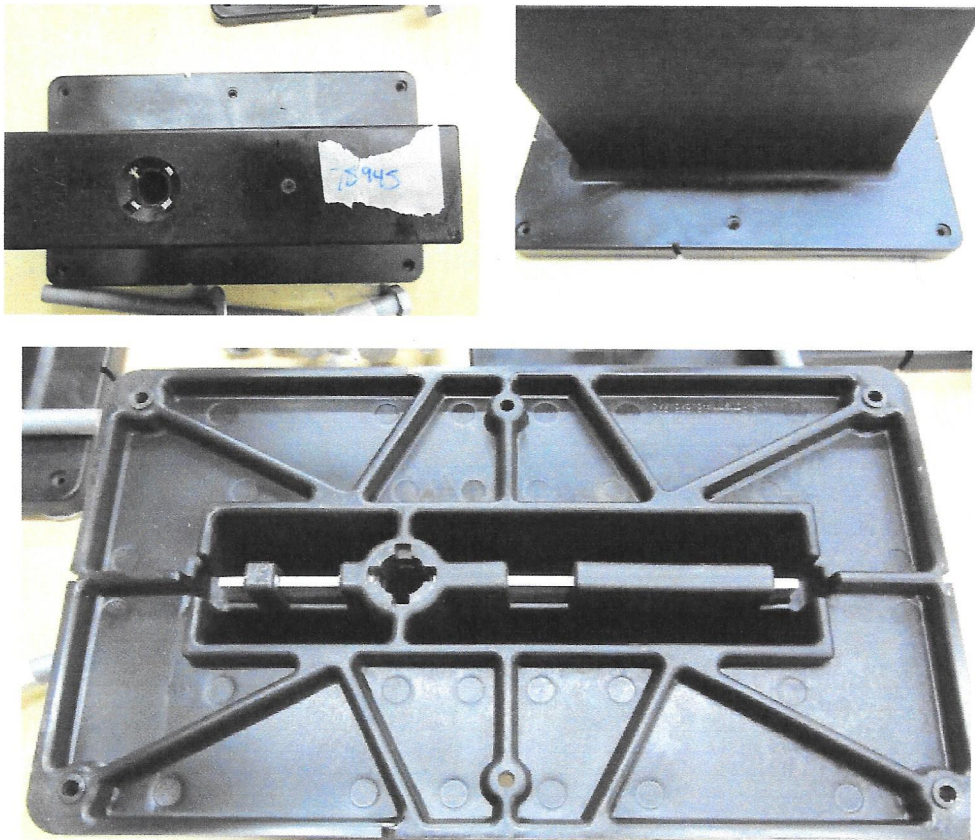
Figure 18: Brick Brackets after Testing
(No Visual Damage was Observed on any Brackets after Testing)

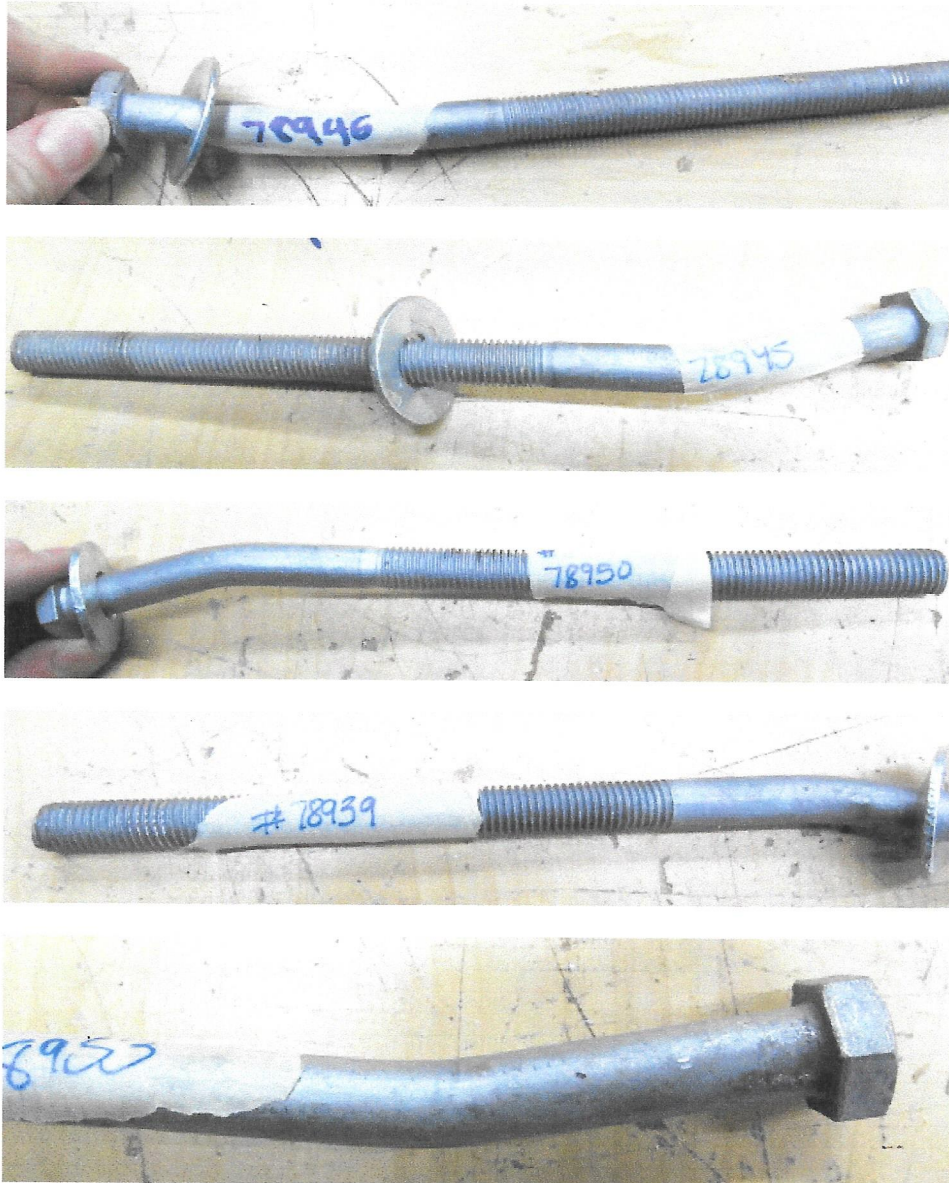
Figure 19: Examples of Bent Bolts Removed from Assemblies after Testing
